**ANNUAL DEPARTMENT REPORT
UNDERGROUND FACILITIES**

December 2024

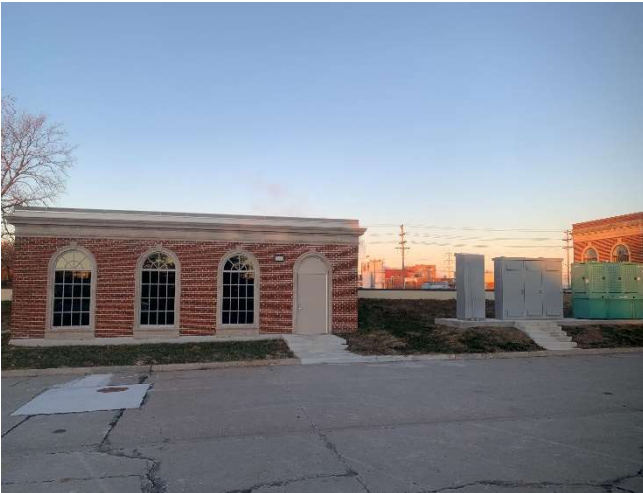
North Street Pumping Station
765 W. North Street

The **North Street Pumping Station** was constructed in 1945. This station is operated daily. It can operate alone or with the Miami Street Pumping Station. A complete renovation of pumps, motors, air system and electrical controls was completed in 2024. Currently, we have remote SCADA capabilities to control the pumps in this station. The dispatchers have control of all pumps. In a loss of power the station is supported by a 200kw diesel generator and transfer switch. The generator will start automatically when power is lost and can operate up to two pumps simultaneously. High service pumps #1, #2, #3, and #4 are in the North Street Pumping Station.

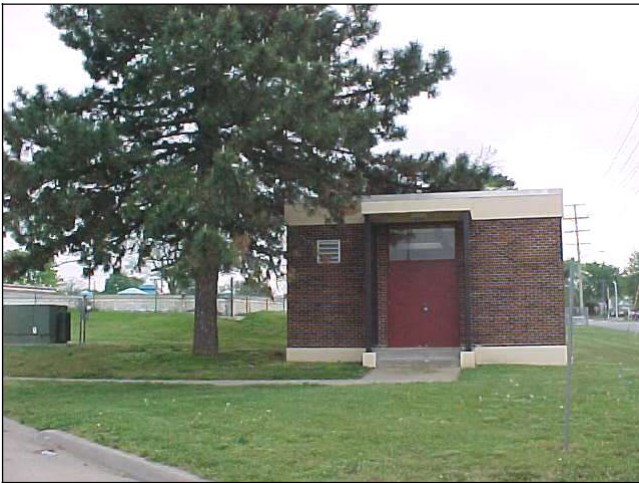
Miami Street Pumping Station

The **Miami Street Pumping Station** was constructed in 1972 when Wilson Foods located their new facility in Marshall. It was renovated in 1989. This pumping station can operate alone or together with the North Street Pumping Station. This is a well-constructed and well-maintained building. The exterior brick and stonework are in good condition. High Service Pumps #5, #6, & #7 are in Miami Street Pumping Station.

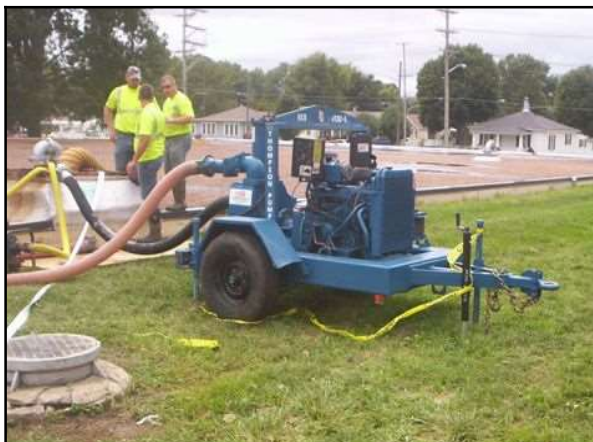
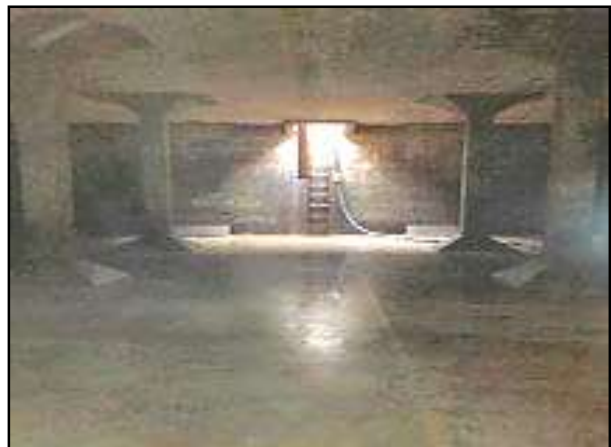
Reservoir #1 is an underground water storage tank located at the North Street Pumping Station. The pumping station and reservoir were constructed in 1945. The storage capacity of Reservoir #1 is 1.75 million gallons. Draining, cleaning, and inspection of this reservoir were completed in 2014 by MMU personnel. Approximately ½ inch of lime sludge was removed from the reservoir floor. The interior floors, walls, piers, and ceilings are in good condition. The reservoir should last for many years. Mixers were installed in July 2017, as part of the THM reduction project. Cleaning was done in August 2024, no major issues were found.

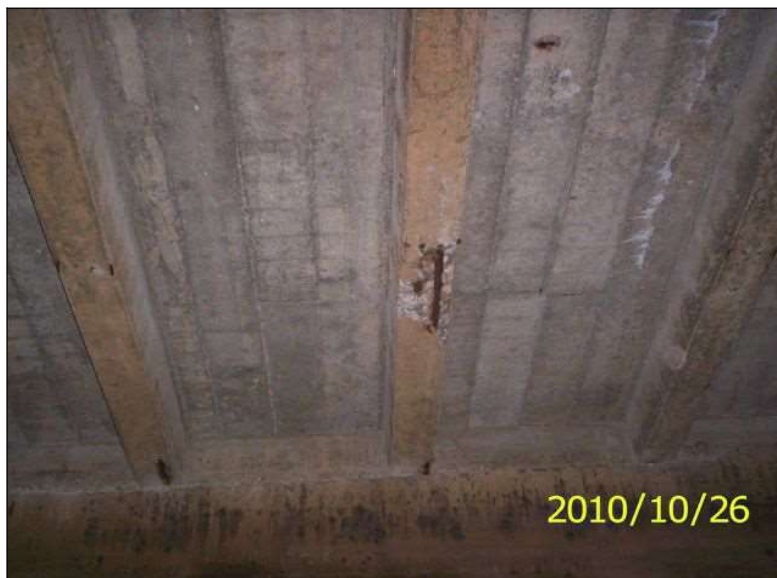
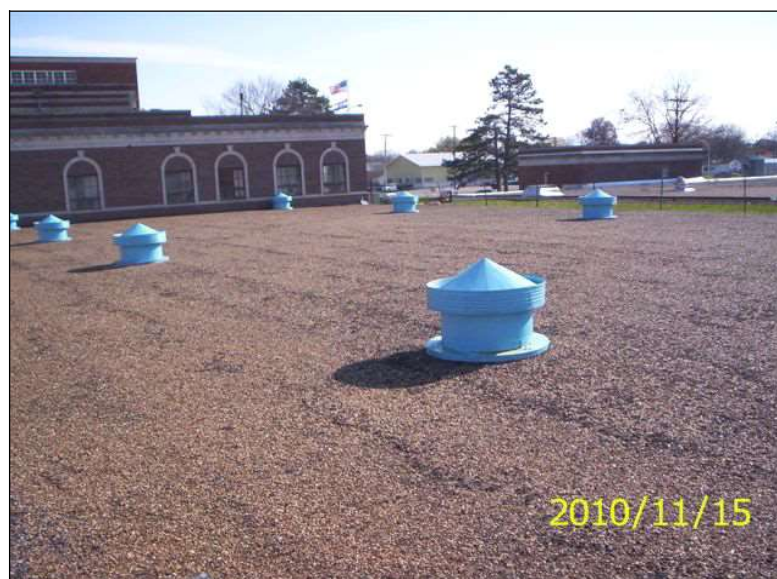
Reservoir #2, constructed in 1936, is an underground water storage tank located between Reservoirs #1 and #3. The storage capacity of this reservoir is 800,000 gallons. The structural integrity of this reservoir is questionable. An interior inspection of this structure by the engineering firm of Black and Veatch in 1985/86 indicated exposed steel on the roof area and loss of concrete around the structural steel. Based on information received from Black and Veatch's report, it was determined that, for the safety of personnel, the upper part of the reservoir should be vacated. We installed a security fence around the structure to keep the general public from walking on it. The reservoir was removed from service and inspected in 2010. MMU personnel drained the reservoir and cleaned the floor. Small amounts of concrete debris were removed from the floor. Repairs were made on all the entryways and vents. Some repairs were needed on the exterior walls. New storage at the water treatment plant will cover this loss of storage. The reservoir is scheduled to be taken out of service and demolished.

- a) Removal of number 2 reservoir
- b) Upgrading the Miami Pump Station
- c) Major improvements in the distribution system
- d) Transmission main replacement

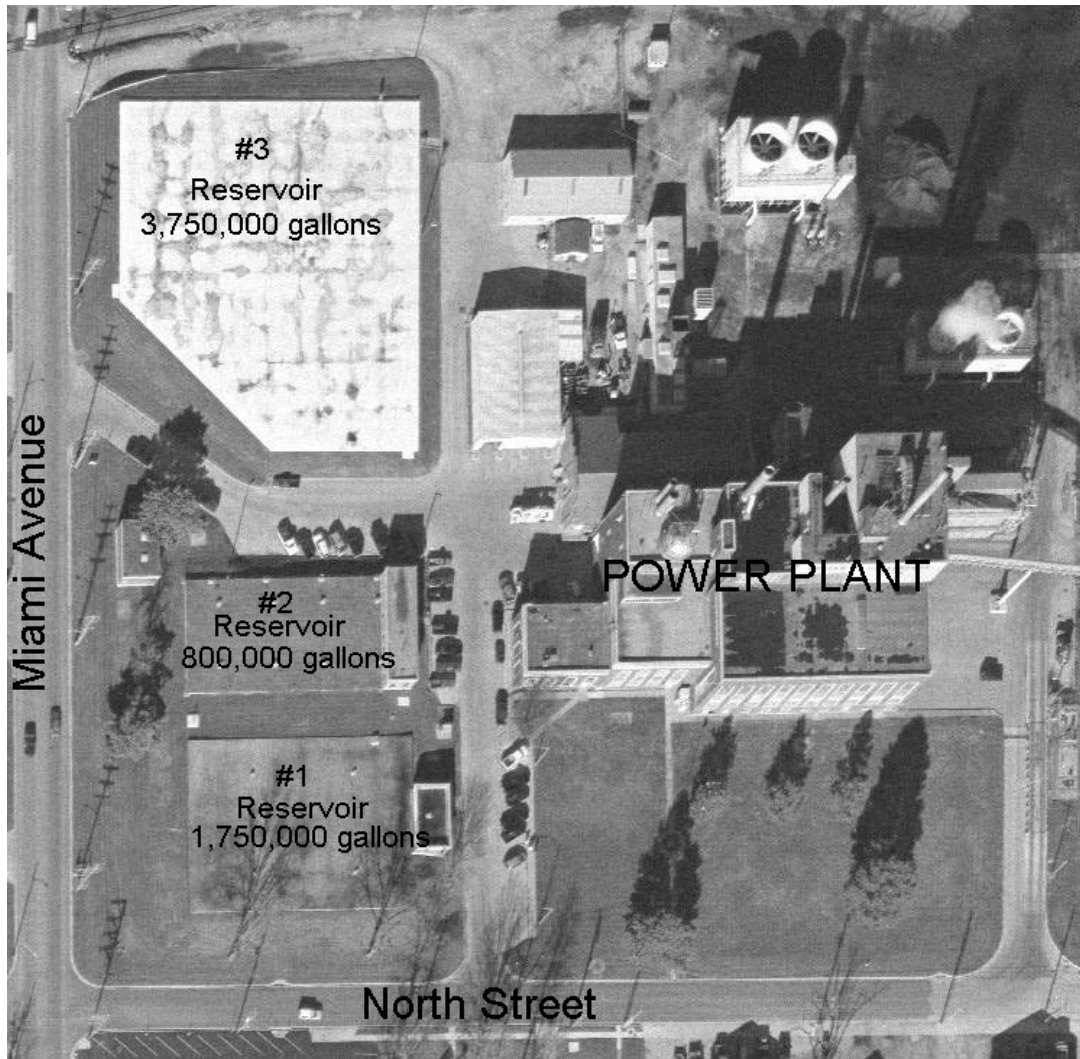
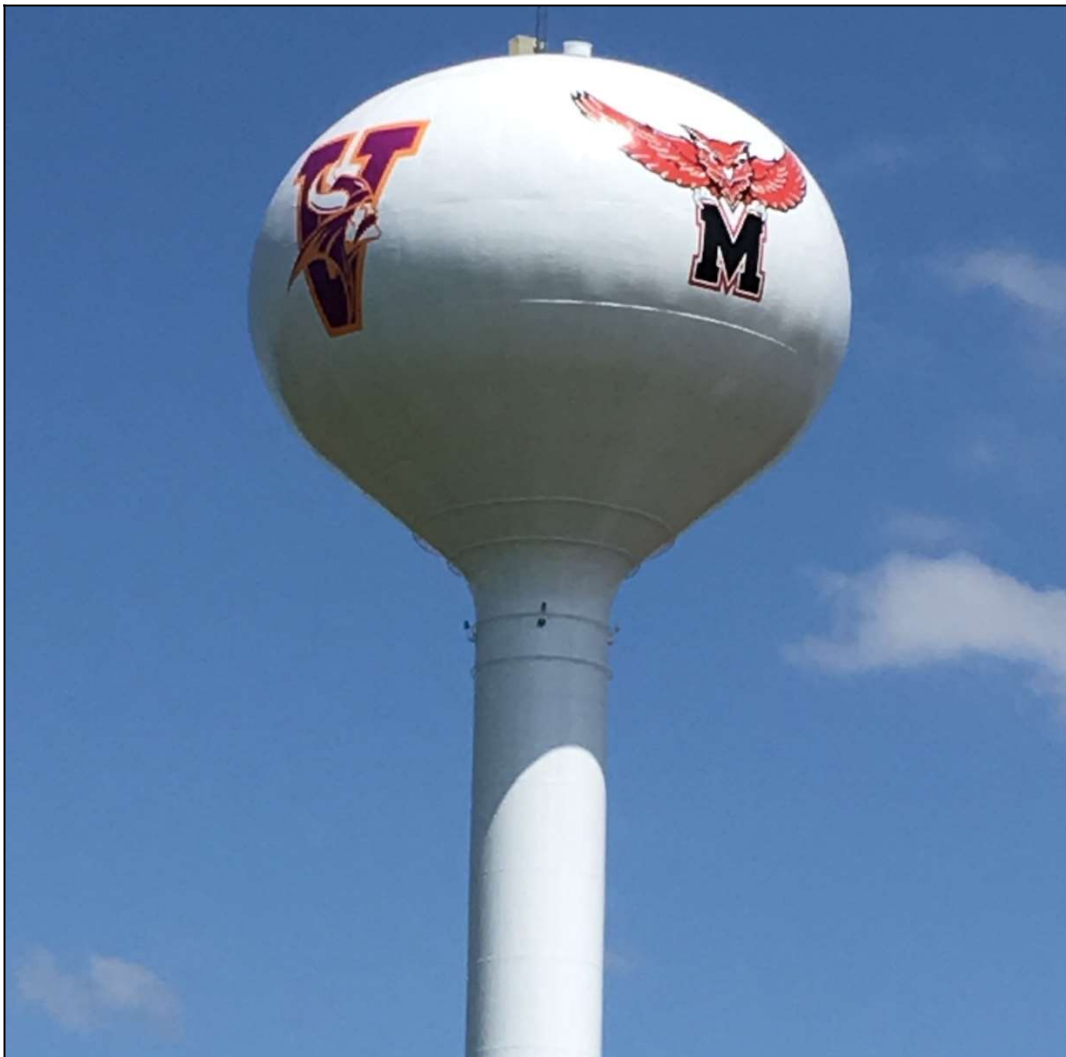
The 500,000-gallon spheroid elevated *water storage tower* is in the southeast part of Marshall just outside the city limits. Universal Tank Company erected this tank in 1979. In the fall of 1995, the interior and exterior of the tank were repainted. In July of 2017, the tank was taken out of service and inspected by Ozark Applicators. The exterior coat was in good condition but showing signs of chalking. The interior dry area is showing light rust, but the primer is still in good condition. The interior wet area of the tank has a few scattered small rust spots and stains. Overall, the tank is in good condition. The tank was inspected when taken out of service to install the new mixing system as part of the water treatment plant THM reduction upgrades. The tank exterior was repainted in the fall of 2018. The tower was taken out of service in Fall 2024, to have the interior wet area sandblasted and recoated.
